# A Case Study;

## Norway, Maine Community Drinking Water

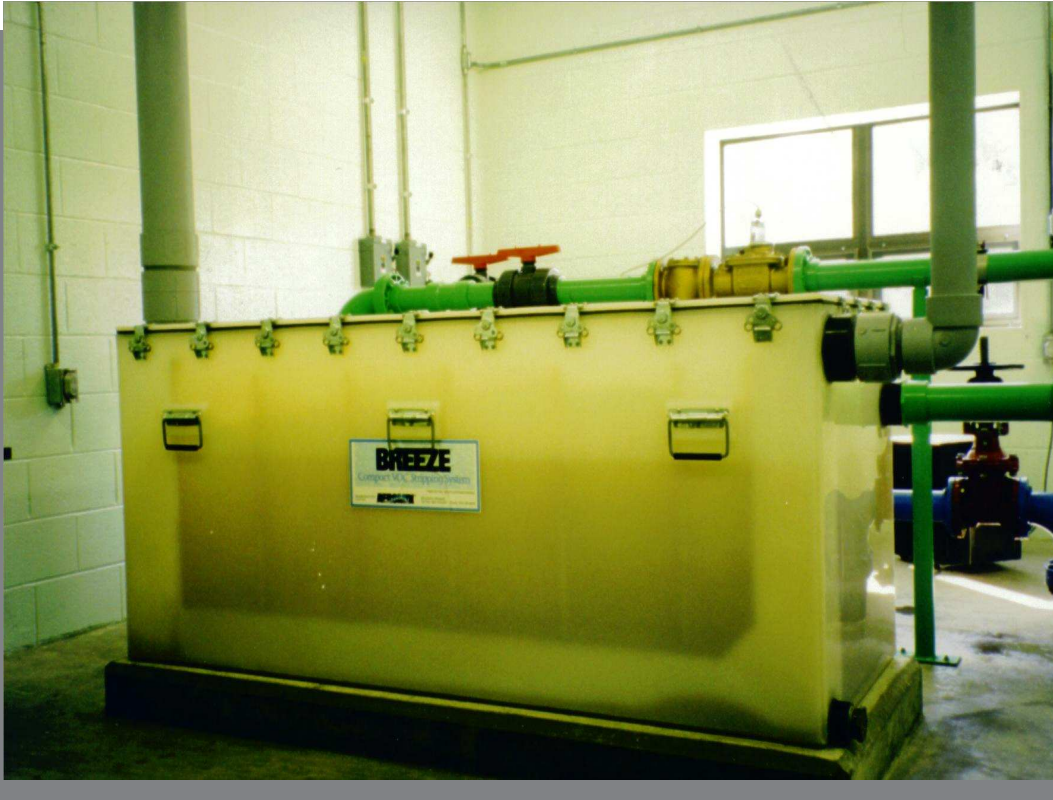
Four (4) Series Six (6) BREEZE Compact Air Strippers, with 5HP air blowers, were installed to treat the drinking water supply. First, the water from the well was treated with Sodium Silica, to help suspend iron. Then the water was fed directly into the four BREEZE units operating in parallel. The Carbon Dioxide and Radon were stripped

as the water passed through each BREEZE tank, and was then vented harmlessly into the atmosphere. The BREEZE Compact Air Strippers continuously removed Radon from 1200 pCi/L to 18, and removed the Carbon Dioxide such that the pH changed from 6.4 to 7.3. It was reported by the operator that by simply removing the covers on the

BREEZE tanks to clean out precipitation and solids, maintenance was only required once a year.
